## Open Field Revegetation

### Existing & Proposed Conditions:

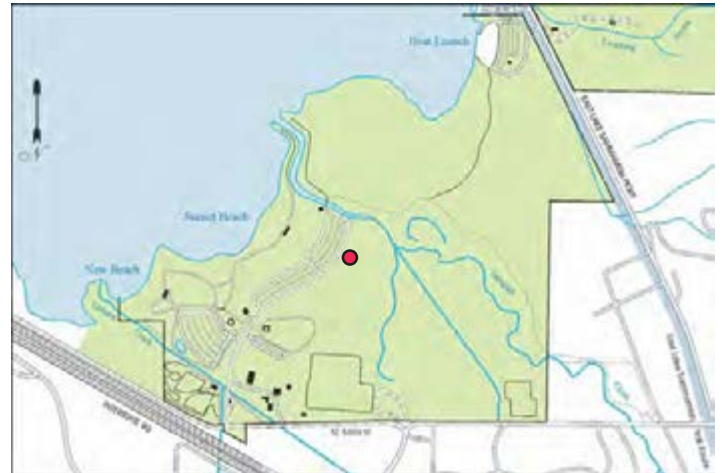
● Project location

This wetland is approximately 5.7 acres in size, located to the southeast of the Sunset Beach parking lot. Bat boxes on poles were installed here as a Boy Scout project several years ago. The wetland is comprised of mostly reed canarygrass with blackberry edges and some patches of soft rush. There are willows and cottonwoods beyond the field margins. Several ditches direct water from and through this area to a ditch paralleling the Sunset Beach parking lot.

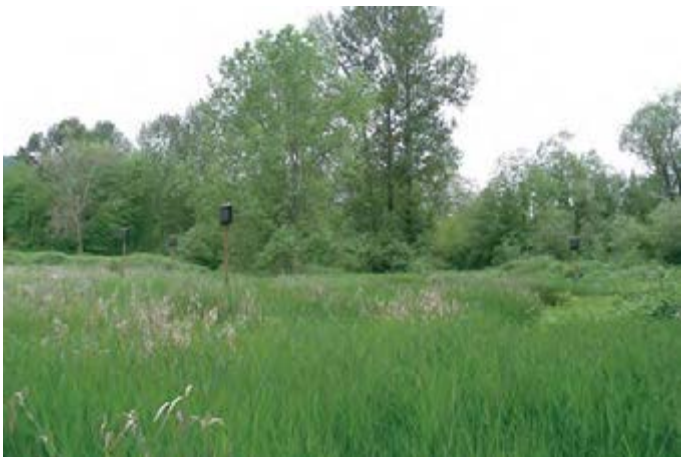
This site has potential for wildlife habitat enhancement

The natural habitat values of this wetland could be increased by mowing the reed canarygrass and installing dense patches of native trees and shrubs. Plant species should be chosen for their wildlife food and cover characteristics. It is also recommended that several of the existing bat boxes be moved from the installed poles to adjacent tree trunks to possibly increase their use by bats. Bat slabs could also be installed on some of the trees to investigate their relative use compared to the boxes. An interpretive sign explaining these habitat structures is a good educational opportunity, especially since this is near a trail and visible from the Sunset Beach parking lot.

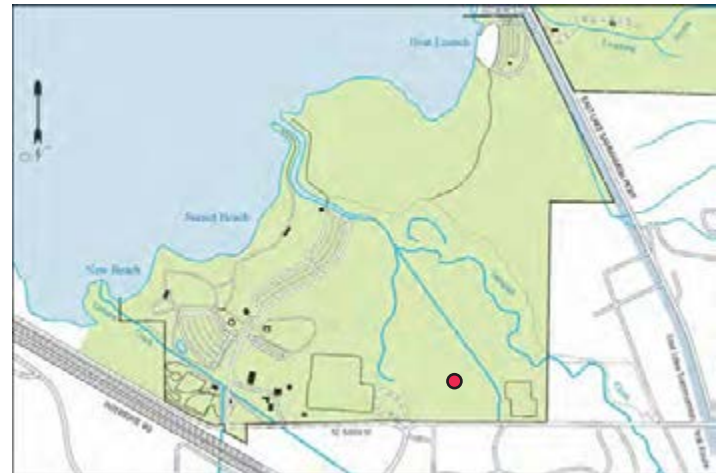
● Project location

The area between the two sets of soccer fields is a combination of wetland and upland features, approximately 23 acres in size. A ditch near the eastern “Costco fields” directs water northward into Issaquah Creek. Much of the area is open grassy field dominated by a variety of grass species, thistle, vetch, and horsetail. Blackberries are dense along the edges of the field with some willow, rose, cottonwood, ash, and hawthorn thickets. This wetland area was delineated and identified as part of Wetlands 6A and 6B in Wetlands Inventory for the Lake Sammamish State Park Property (The Coot Company, 2005). The report also indicates that the ditch near the eastern soccer fields receives significant input from storm-water runoff from the City of Issaquah.

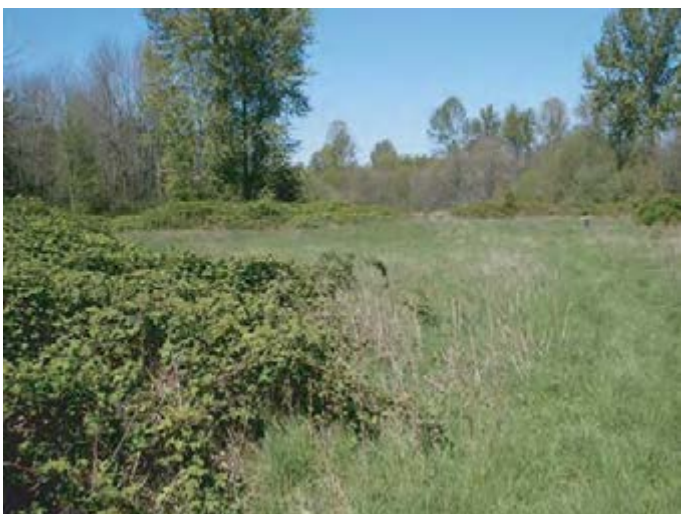
Himalayan blackberry dominates edge of the wetland

This area could be restored and enhanced with removal of blackberries and revegetation at least on the edges of the existing field. Scattered islands of native trees and shrubs planned to correspond to wetland and upland conditions would provide additional food and cover values for wildlife habitat. As the area is near an existing trail, an interpretive sign could be installed to explain habitat enhancement and the value of additional

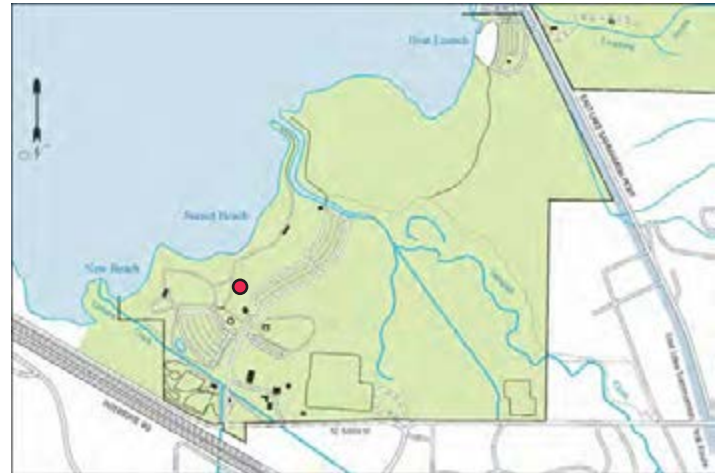
● Project location

This mostly upland forest area is approximately 2.8 acres northeast of the New Beach parking lot. The existing plant community is dominated by black cottonwood, red alder, Oregon ash, snowberry, osoberry, red-osier dogwood, and salmonberry. Blackberries, both Himalayan and evergreen, have taken hold with reed canarygrass along the edges of the forest.

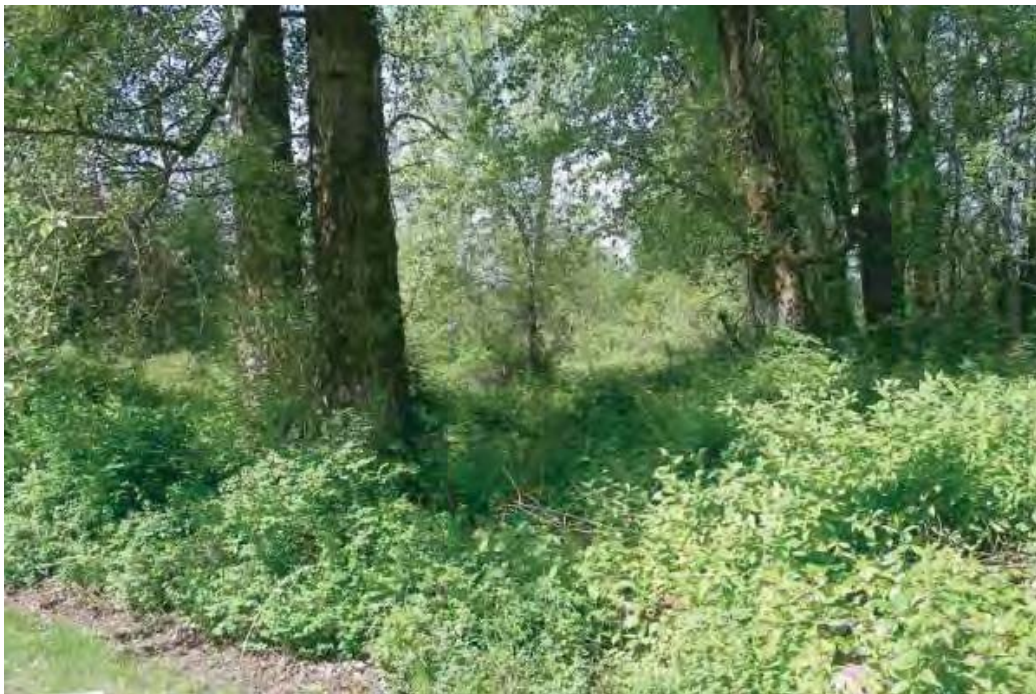
Edge of the upland forest

The fairly diverse forest community could benefit from removal of invasive plants, particularly blackberry and reed canarygrass. Follow up with additional plantings of shrub species to combat invasive weeds and improve habitat values would improve project success. Plantings could include more of the existing shrub species, additional upland shrub species chosen for their food and cover values, and conifers to increase the habitat diversity of the overall area.

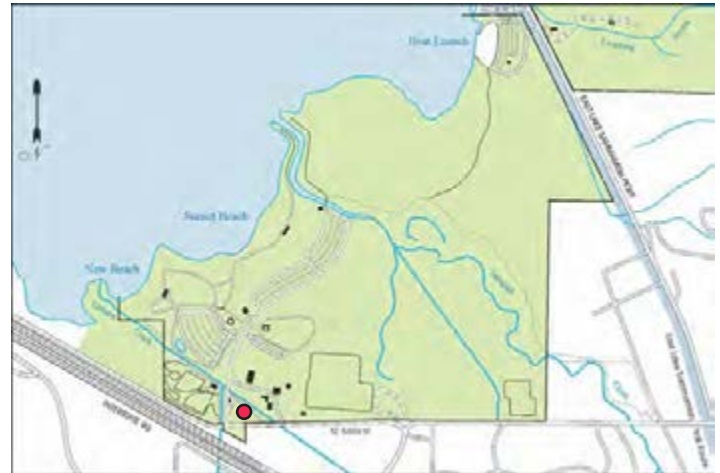
● Project location

East of the park entry road and south of Tibbetts tributary #0170, the existing wetland/forested community is dominated by black cottonwood, red alder, and Oregon ash in the canopy. The understory is comprised of willow, red-osier dogwood, rose, twinberry, snowberry, osoberry, and blackberries. Blackberry thickets, both Himalayan and evergreen, are dominant along the edges with reed canarygrass. The wetland was identified as Wetland 8 in Wetlands Inventory for the Lake Sammamish State Park Property (The Coot Company, 2005).

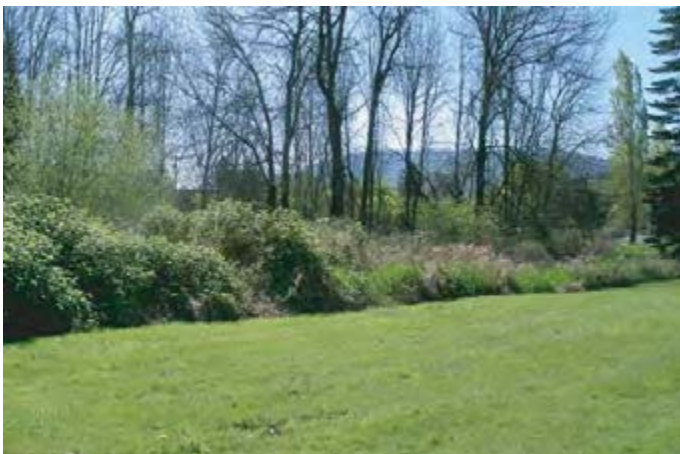
Invasive plants and lawn in the wetland buffer

This fairly diverse community could benefit from removal of invasive plants, particularly blackberry, English ivy, and reed canarygrass. Follow up with additional plantings of the existing shrub species to combat invasive weeds and improve habitat values would improve project success. Wetland buffer plantings could be established along the west side of the wetland which is presently mowed grass. A diverse community of upland shrubs and trees, including conifers would add to the habitat value of this area.

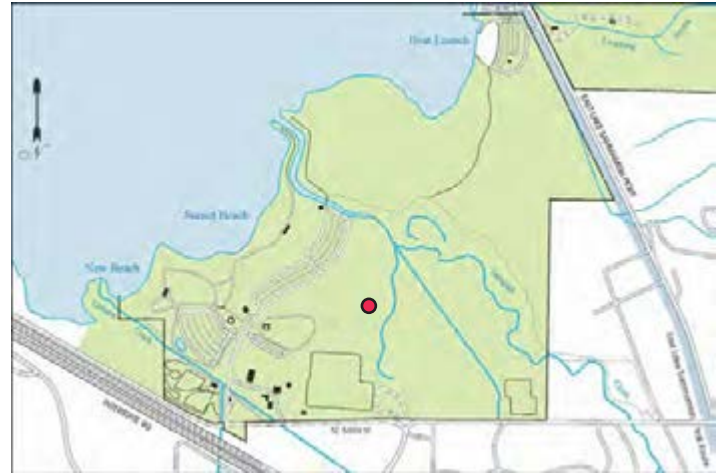
● Project location

A field northeast of the main (western) soccer complex is approximately seven acres in size. There is a ditch along the southwest side between the maintained soccer area and this field. This area is presently dominated by reed canarygrass, fairly large patches of slough sedge, and horsetail with scattered Oregon ash trees. Blackberry thickets are present throughout and particularly along the edges of the field. Edge habitat between the different plant types is well-distributed. This area was not specifically delineated in Wetlands Inventory for the Lake Sammamish State Park Property (The Coot Company, 2005), but was identified as part of Wetland 6.

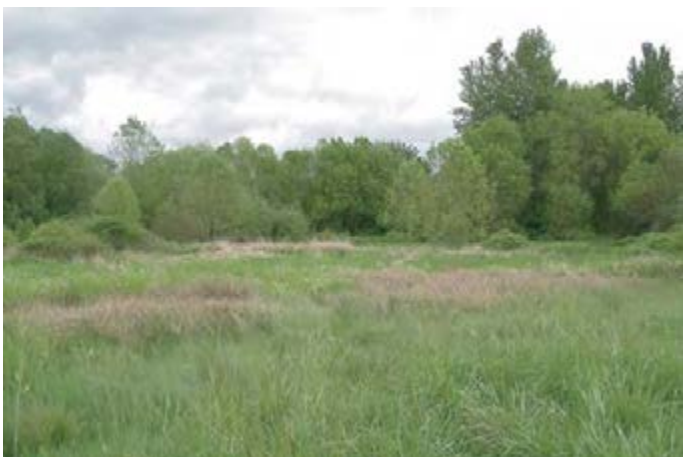
Existing open field is dominated by invasives

Removal and/or control of blackberry and reed canarygrass would be beneficial to the habitat value of this area. Follow-up revegetation should include plant species chosen for their food and cover values for wildlife. The habitat values of existing tree and shrub thickets could be expanded and improved with additional species diversity. This project could be combined with Project A9 for enhanced educational and passive recreational opportunities.

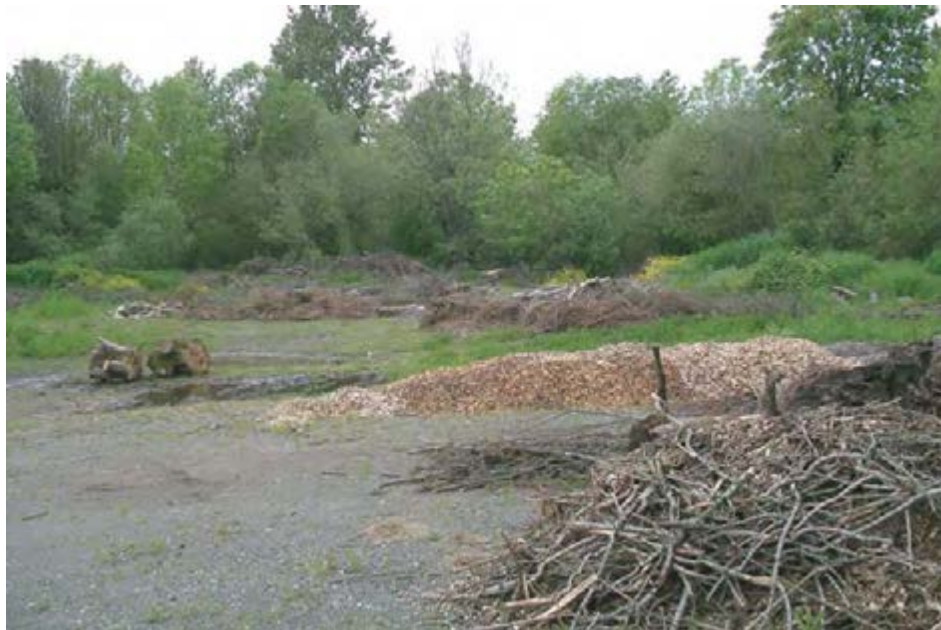
There is an informal park compost area north of NW Sammamish Road between the two sets of soccer fields. This area could be organized into a more efficient composting operation that would provide materials to be used throughout the park and for restoration projects. Revegetation along the edges could help to define and screen the composting area, as well as prevent encroachment into the surrounding natural communities.

The informal composting area

This operation could also serve as a “how to” interpretive area to explain composting. Various stages of decomposition could be shown resulting in potting soil quality, vermicompost (worm bins), and information about not attracting pests, such as rats and other rodents.

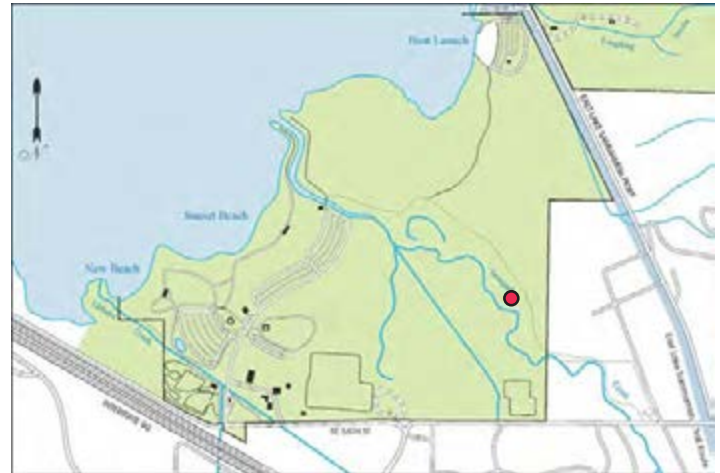
● Project location

Along the right streambank at this location is a vertical streambank 10-12 feet high and approximately 150 feet long. The vegetation extending landward from the top-of-slope is primarily grass and weeds. In contrast to a number of other possible project locations with somewhat similar vertical banks, the active stream flow here has moved away from the toe, leaving a sandy, gravelly bar. As such, the proposed project treatment is also somewhat different.

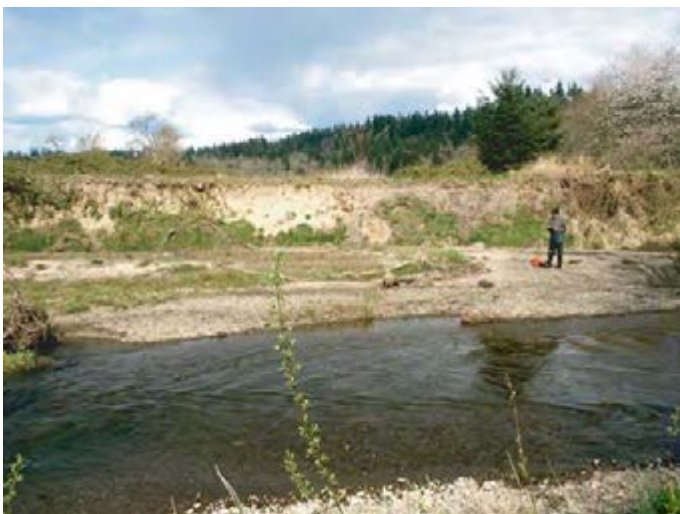
High bank along Issaquah Creek

Rather than re-sloping the banks at this location, it is instead proposed that a myriad of willow and cottonwood stakes and/or rooted bare root stock be densely planted across the entire gravel bar area. A few willow seedlings have already begun to grow there. If this vegetation can become well-established before the stream channel attempts to migrate through this area again, it will facilitate continued aggradation and flood plain formation across the bar area, keeping erosive flows away from the toe of the vertical bank. This is a relatively low-cost project suitable for implementation by volunteers with hand tools, involving only relatively straightforward permitting issues.

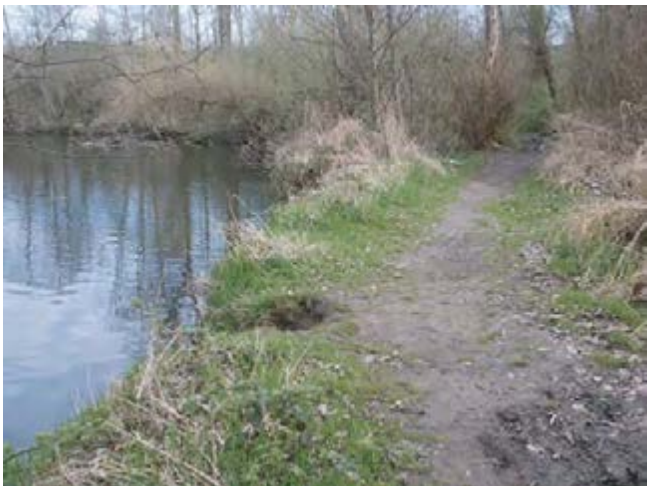
Along the east bank of Issaquah Creek, between the mouth and just upstream of the footbridge, seven relatively small “patch” areas between the existing trail and the creek have been identified that would benefit from some combination of invasive plant removal, revegetation with native plant species, trail realignment, picnic area creation, and in-stream log structure placement. Because each of these areas would, by itself, constitute a fairly small project, they have been grouped together as a single project for consideration:

Streambank of Issaquah Creek along an unpaved path

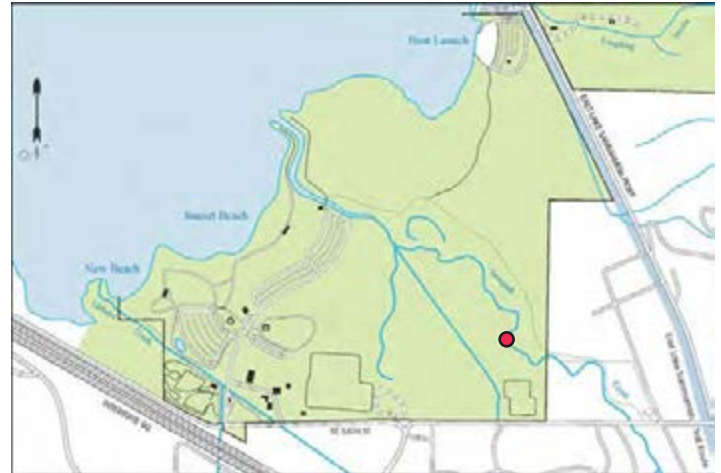
● Project location

Along the left streambank at this location is a vertical streambank 10-12 feet high and approximately 150 feet long, similar to those described at other locations along the creek in that respect. The vegetation extending landward from the top-of-slope is primarily grass and weeds. In contrast to previous possible project locations with somewhat similar vertical banks, however, groundcover vegetation growing along the lower banks indicates that the bank may be more stable with less active ongoing erosion. Though water still flows past the toe of this bank, small gravel bars have formed and woody debris has accumulated on them.

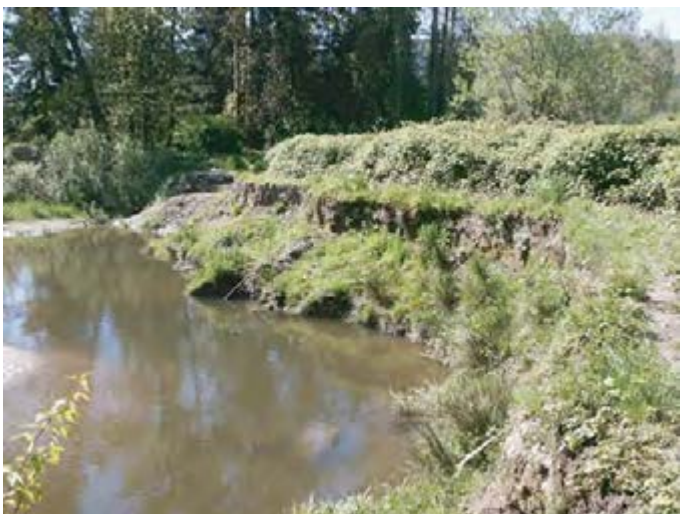
Revegetation would stabilize the existing streambank

As such, the proposed treatment for this vertical bank section is somewhat different than for some of the other vertical-bank sections. As proposed, this project entails densely planting the lower banks, primarily, with seedling alders rather than re-sloping them. Invasive vegetation removal and native revegetation above the top-of-bank would also occur.

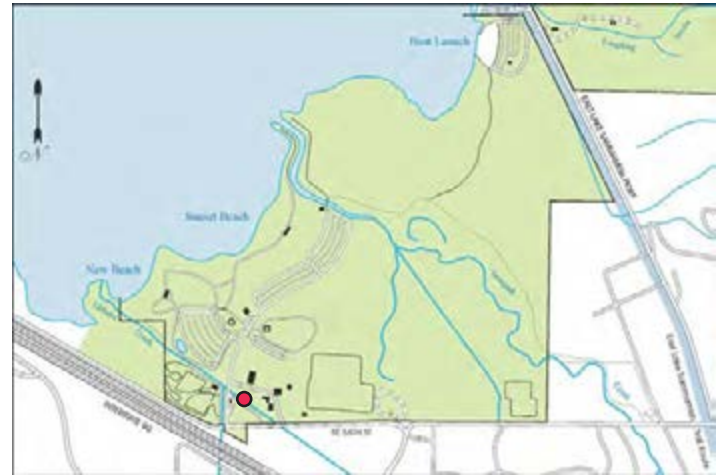
● Project location

Tibbetts Creek tributary #0170 flows in a straight, ditch-like channel south of the park's offices and maintenance buildings between SE 56th Street and the park entrance road. The tributary joins Tibbetts Creek on the west (downstream) side of the entrance road at the point where Tibbetts turns to the west, away from the road. On parks property, the tributary flows in a straight, excavated channel that dates from the period when the area was cleared and drained for farming early in the last century. Several similar and parallel excavated drainages occur in the park to the northeast. The tributary is low-gradient with a silty channel. It presently lacks woody materials in and along it which would provide habitat cover. Vegetation along its lower section on-site is wanting, consisting almost exclusively of invasive and non-native reed canarygrass and Himalayan blackberries. Farther upstream, on-site vegetation improves, including maturing conifer trees, salm-onberry, snowberry, sword fern, and lady fern, however invasive English ivy is also present.

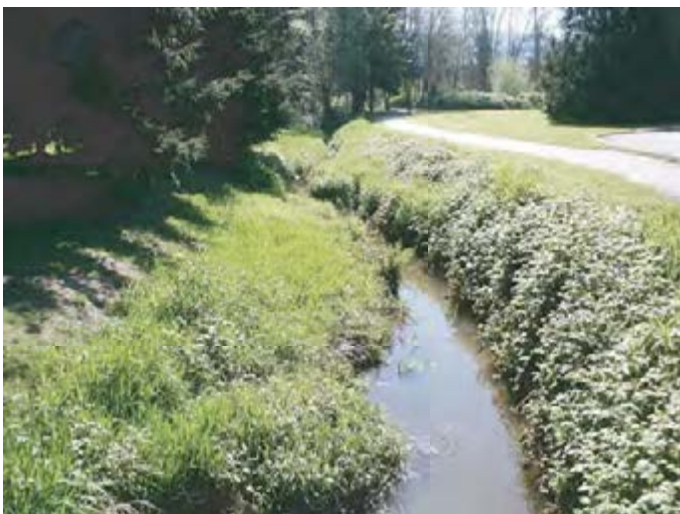
Existing Tibbetts Creek tributary #0170

Project recommendations for this area focus on the removal of invasives including Himalayan blackberries, reed canarygrass, and English ivy from along the banks and their replacement with a diverse assemblage of native plant species. Some areas appear to have been mowed in the past, and this could be done again but would have to be followed up with physical uprooting and (possibly) judicious herbicide use on re-growth. Banks would be replanted similarly to the existing, well-vegetated central section, but with increased diversity of native plants. Widening of the flood plain could also be done, and would be beneficial, but would involve shifting the trail. Large woody materials could also be placed within the channel as habitat features, but at a lower priority than for similar actions recommended for Tibbetts and Issaquah Creeks.

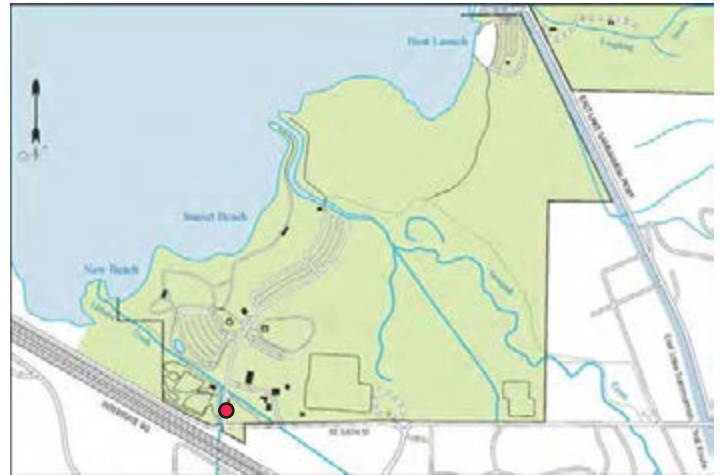
● Project location map

The existing park entry road is adjacent to the east side of Tibbetts Creek and limits the width of the stream buffer in this area. This project would relocate the park entry road further to the east in an area of mostly existing lawn to create a larger and more effective stream buffer along Tibbetts Creek.

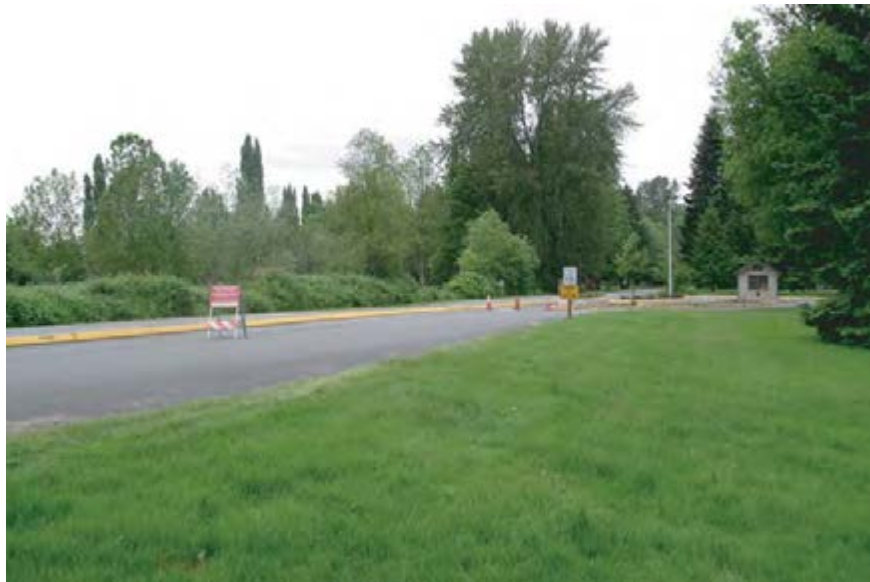
Existing entry road precludes buffering to Tibbetts Creek nearby

The width of the stream buffer and exact location of the new road would need to allow for an enhanced wetland buffer along the wetland area south of Tibbetts tributary #0170, as described in Project A16. Interpretive signage could be installed along the trail in this area explaining the reason for relocating the road as an additional feature of the Tibbetts Creek Greenway restoration work. Additional floodplain along Tibbetts Creek could also be created as part of this stream buffer restoration and could be combined with Projects A1 and C9.

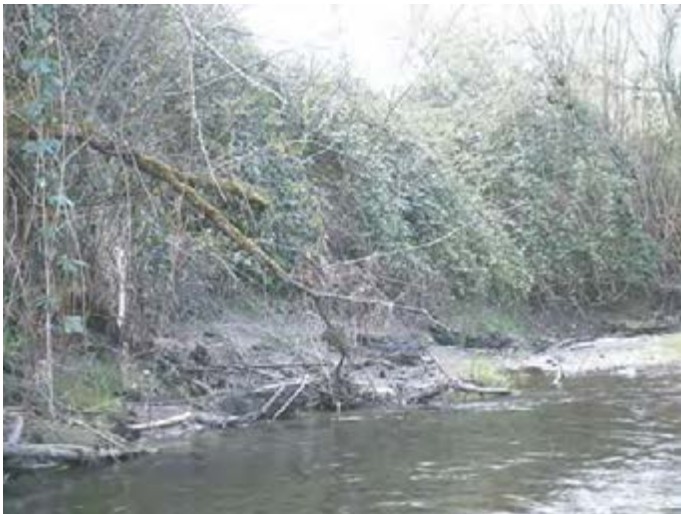
Centrally-located along the portion of Issaquah Creek on-site is a relatively straight and narrow channel section confined by dense blackberry thickets on both sides. This section has comparatively low levels of woody debris and, unlike the channel sections immediately upstream and downstream of it, has relatively little bank erosion.

Existing streambank

The project envisioned for this section would, primarily, provide for the placement of a number of habitat structures in the stream channel, composed for the most part of logs with attached root wads. The equipment access needed to place these structures would be through the adjoining dense blackberry thickets. Blackberry removal and native revegetation would occur along equipment access routes at a bare minimum but would more likely also occur over a somewhat or considerably larger area as well.

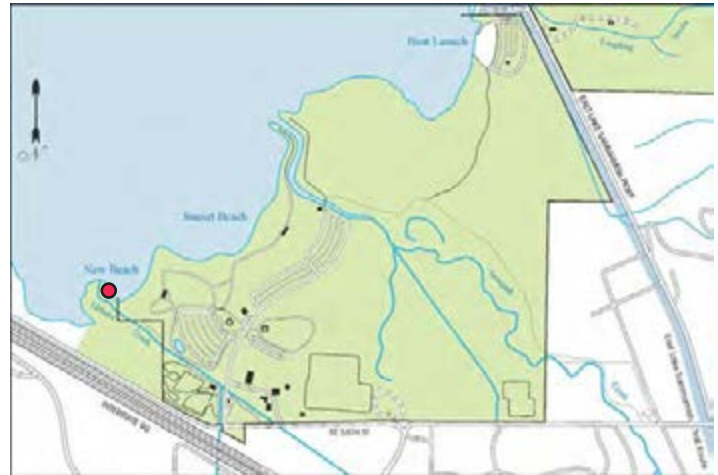
● Project location

The trail from the New Beach parking lot to the mouth of Tibbetts Creek is an informal muddy trail that is under water for some parts of the year when the lake level is high. This trail, which has an entry sign and appears to be fairly well used, leaves the park property and extends onto the adjacent Greenwood property. On the east side of Tibbetts Creek it goes along the lakeshore and through associated wetlands, which are dense and complex habitats in this area with large, old fallen willows and evidence of frequent beaver activity.

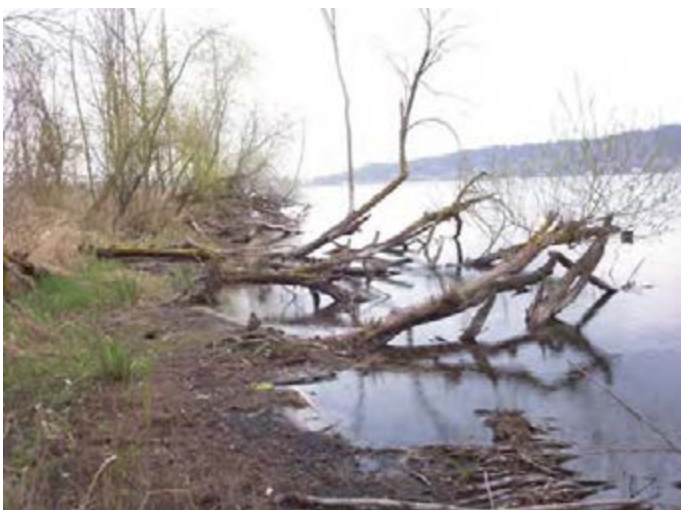
View of shoreline from existing trail

The use of this trail should be managed to limit impacts to the adjacent habitats. Boardwalk sections could be added to elevate the trail above the lake level, or trail sections could be moved to higher ground with an improved trail surface to prevent the on-going widening and creeping of the trail as users try to avoid mud and water. Willow stakes could be installed along the lakeshore, with more trees and shrubs at the mouth of the creek for improved habitat and increased shading to combat reed canarygrass. Hardstem bulrush could be planted along the lake

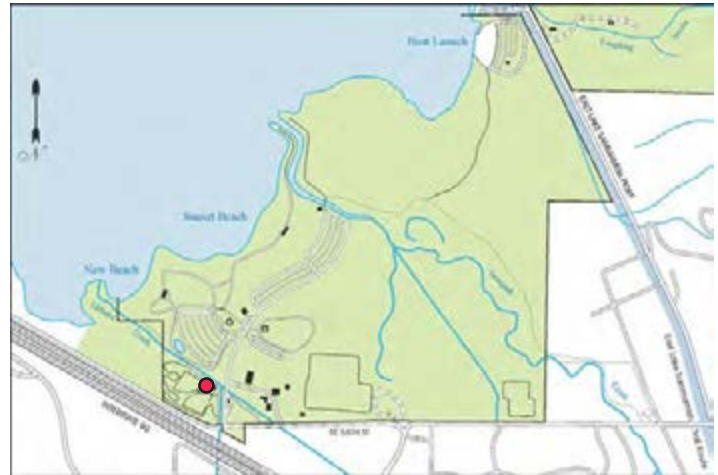
● Project location

Along the northeast side of the baseball fields is a grassy, muddy wetland area which is left unmaintained with the exception of a few mowed trails from the ballfields to the existing restroom. This area is approximately 0.9 acres in size. It is dominated by reed canarygrass with a few scattered shrubs and other weedy species.

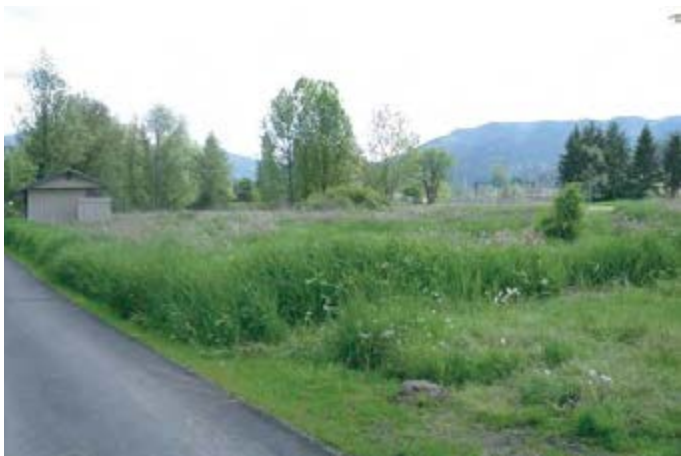
Reed canarygrass dominates the existing wetland

This area could be improved and enhanced to increase wildlife habitat values, and to create an aesthetically pleasing and useful area for families attending baseball games. Additions could include a small shelter with tables, native shade trees and shrub clusters that would provide food and cover for wildlife. Shallow depressions could be created to support emergent wetland plants, combat invasive plants, and increase species diversity and edge habitat. Interpretive signage could be installed as an additional feature of the Tibbetts Creek Greenway restoration work.

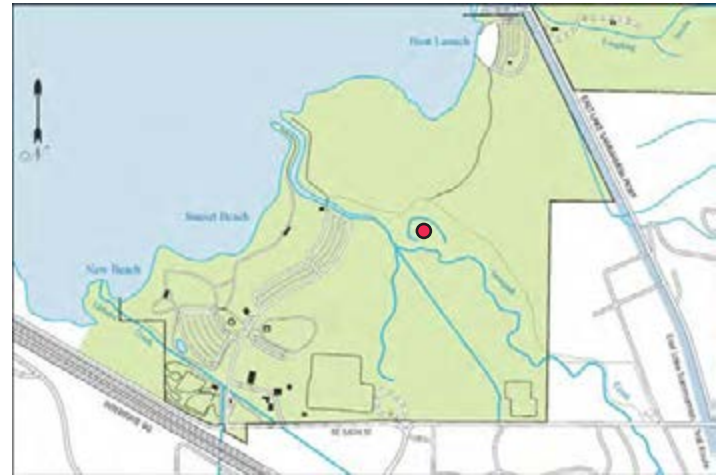
● Project location

A fairly large bend in the stream at this project location was cut off from active flow when the stream eroded a “short cut,” bypassing the bend, some time about a decade ago. This “short cutting” of stream and river channels whereby the flow finds and takes a shorter route instead of its previous meandering, circuitous route is known as avulsion. The cut-off channel section which no longer carries active stream flow is called an oxbow. The area of the oxbow is presently very brushy, including dense Himalayan blackberry thickets, making it fairly inaccessible.

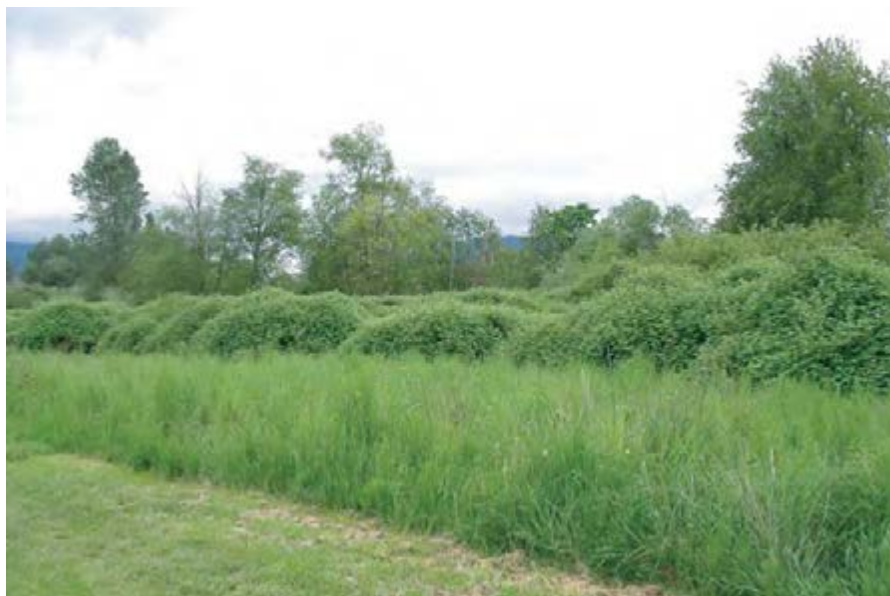
Streambank along the oxbow

As envisioned, this project would include creating a side trail to the area off of the right bank (east side) trail system with well-developed interpretive signage (and possibly an interpretive center) explaining the processes of channel migration, meandering, and avulsion over time. Included would be the concept of a channel migration zone across the floodplain for streams and rivers and an explanation of the various and valuable habitat types that oxbows and side channels provide for a wide variety of wildlife species.
