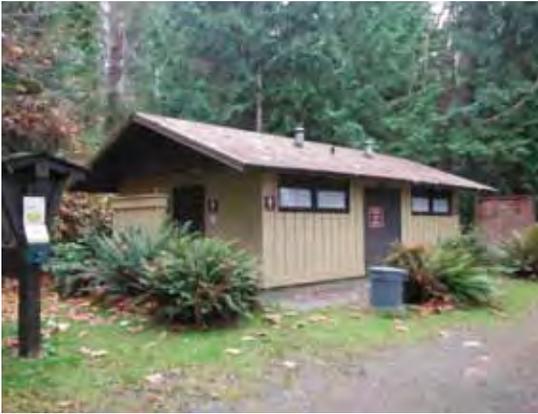
## BEACH

In addition to the same ADA deficiencies noted for the day use area restroom, this restroom, constructed in 1972, also shows non-repairable settling and considerable wood deterioration along the base of the walls. Due to these deficiencies and deteriorated sewer line conditions, State Parks staff should remove the building in order to protect public safety and water quality.

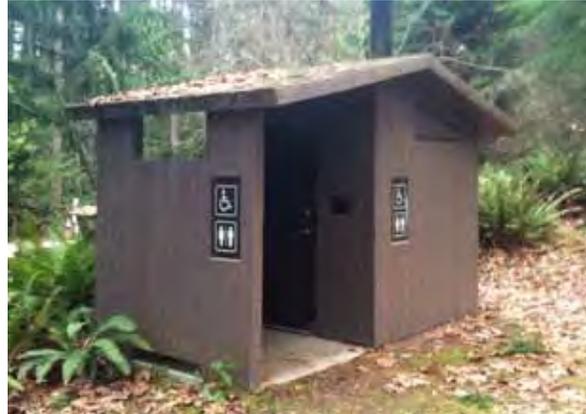
## GROUP CAMP

This building is a precast concrete vault toilet structure. Due to the potential risk of falling trees, this restroom is also closed and it is unlikely that it will be used in the future so long as the risk of falling trees remains. Previous research by Parks staff indicated that the building cannot be reused to replace the beach restroom because of turning radii difficulties for a truck sufficiently large enough to haul the building in one piece as it cannot be disassembled. The restroom has been used as a back-up when the day use restroom was shut down for repairs.

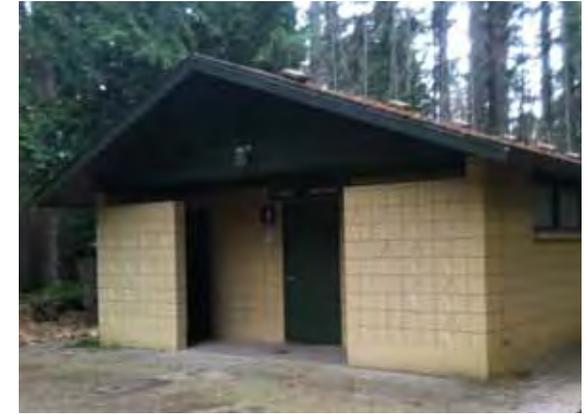
## CAMPGROUND

This building, constructed in 1967, is currently closed and is intended to remain closed because of the risk of falling trees due to laminated root rot. Because of that risk and because it is unlikely that trees will be removed in sufficient number and distance to protect the building, the building should be removed as it does not meet ADA requirements and will continue to deteriorate over time.

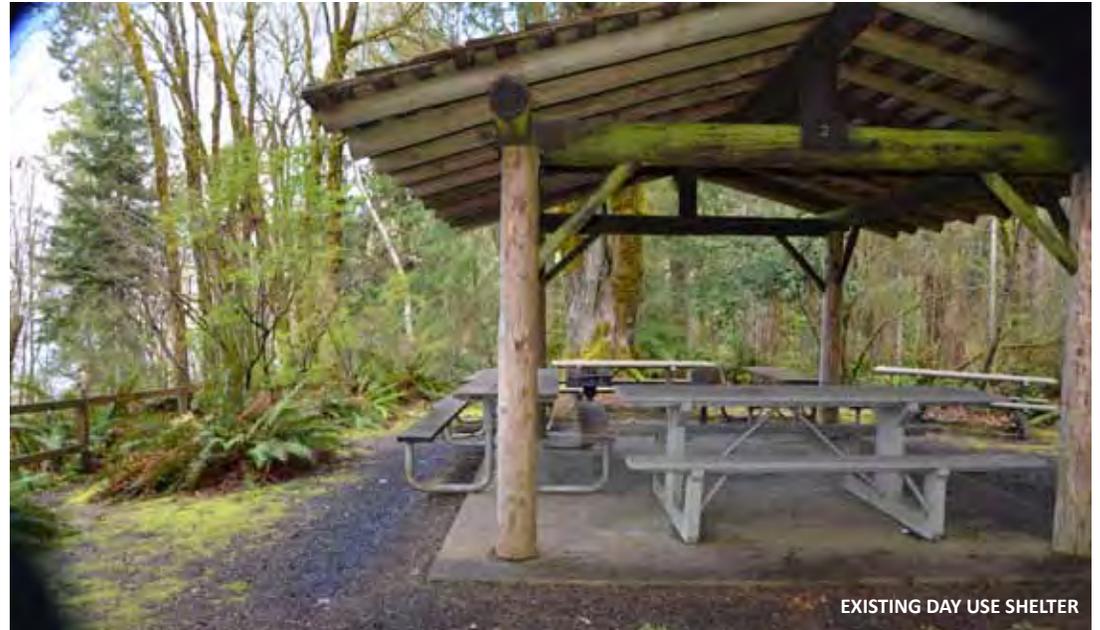
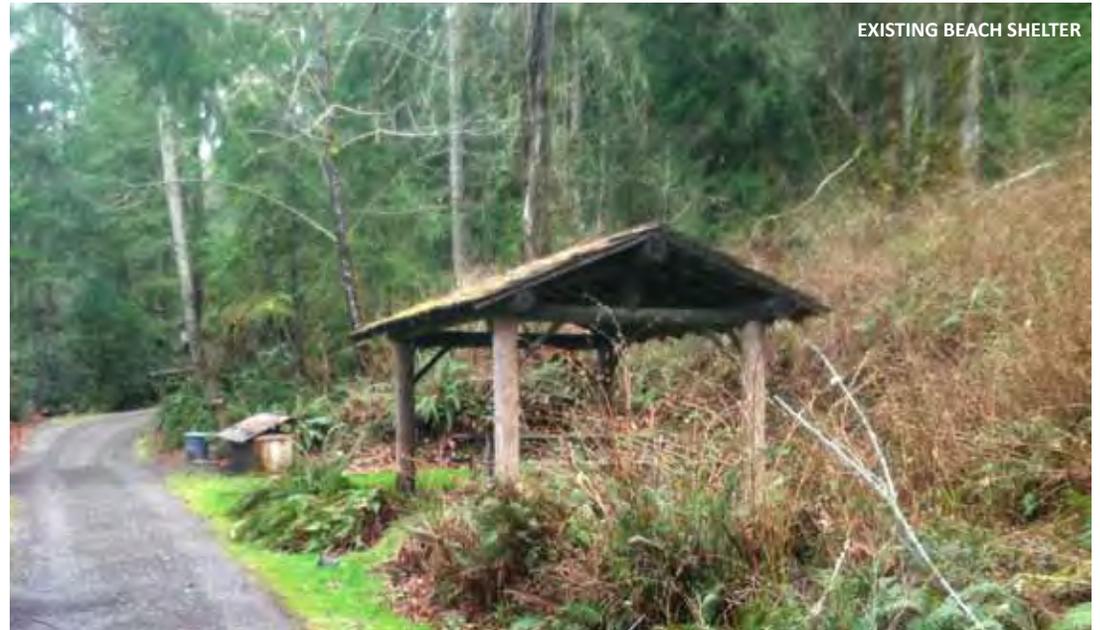
## Open-Sided Picnic Shelters

There are four open-sided, wood picnic shelters (approximately 10' x 20'). With their pole supports and shingle roofs, these structures are the appropriate character and scale for Kopachuck State Park. They should be relocated, if practical, within the site. The structures are currently located at the day use area adjacent to the top of the slope, the beach area, the Cascadia Marine Trail campsite, and the former group campsite.

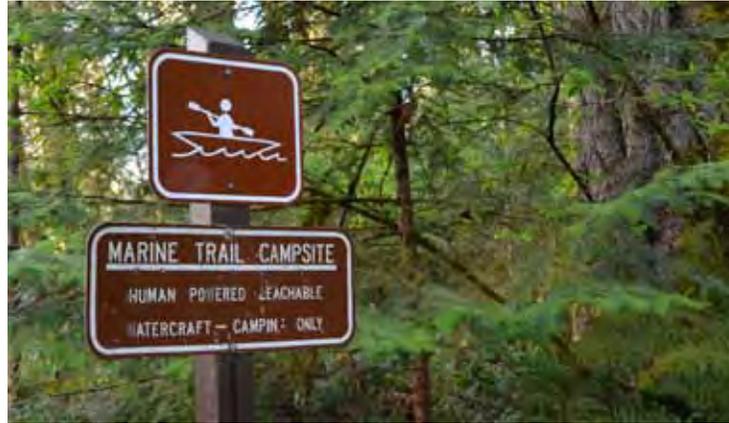
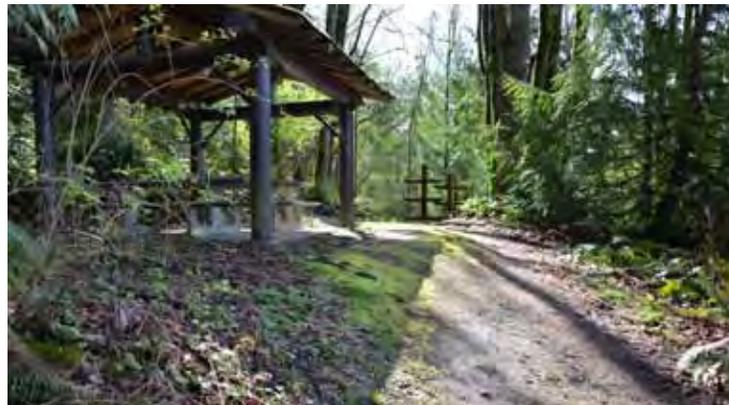
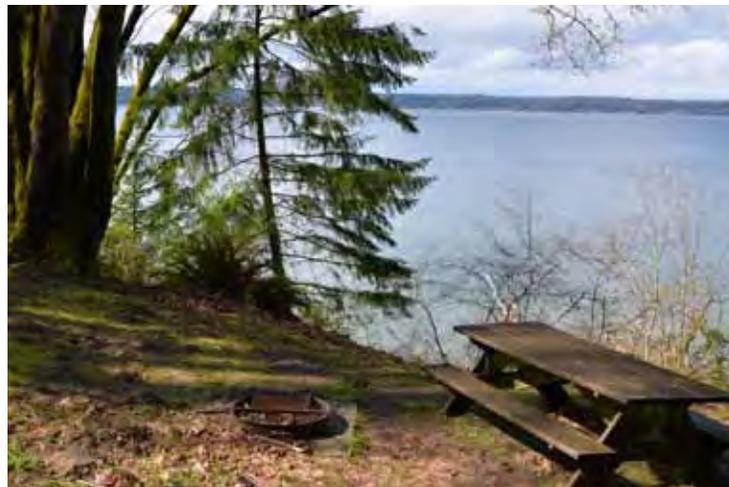
## Marine Campsite

The single remaining camping opportunity in the park is a small campsite on the Cascadia Marine Trail circuit for visitors who approach via human powered beachable watercraft only. The campsite consists of an open-sided picnic shelter, a boat rack, and a small, level area for a tent. As the campsite is fairly high above the water, kayakers do not carry their boats up to the rack at the campsite but rather leave them near the shore. This poses a security concern for the kayakers as they cannot see their boats from the campsite. Furthermore, the steep bank next to the tent site poses a hazard to campers. Therefore, a safer, more accessible location with good visibility to boat storage is preferable.

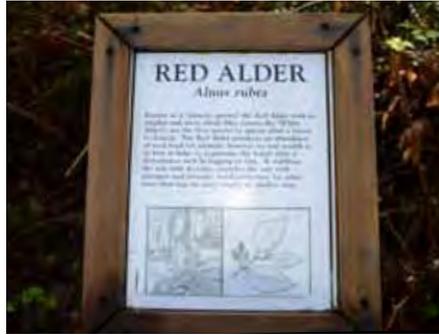
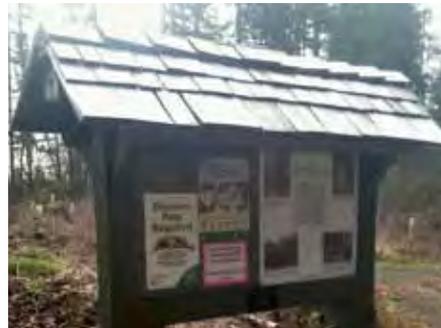
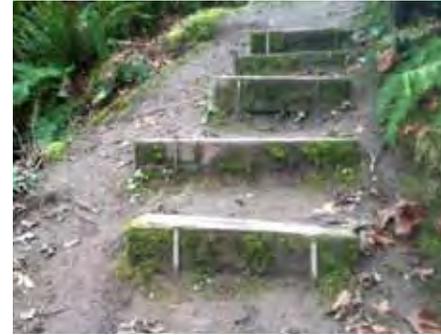
## INTERPRETIVE LOOP

Portions of this trail cross wetland areas. Recent improvements have included grated fiberglass decking which provides stable, dry access while allowing wetland vegetation to flourish. In some areas, log rounds covered with asphalt shingles have been placed as non-slippery stepping blocks. Other sections of the trail are steep and dry. There are several plant identification signs placed around the trail as part of an Eagle Scout project. There is a wood kiosk at the northeast corner of the trail in a roadside area frequently used for parking by trail visitors. It has a sign explaining laminated root rot.

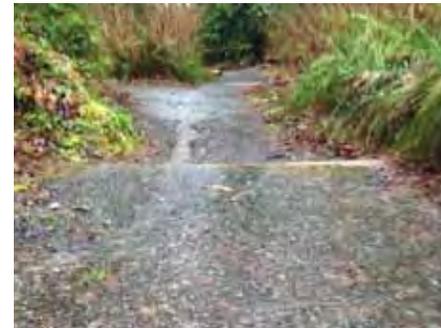
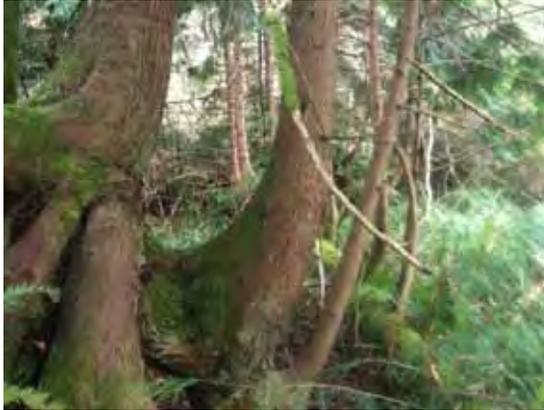
## BEACH LOOP

The beach loop trail provides access from the day use parking lot and picnic area directly to the beach. Virtually all of the soil is poor draining and subject to erosion. Over the years, attempts to arrest the erosion and provide access in steep areas have resulted in a variety of materials and solutions throughout the length of the trail. A small bridge has an unsafe base and portions of the trail close to the beach are constantly shifting. Social trails that have evolved pose risks to visitors because of their precarious locations and conditions resulting from lack of maintenance.

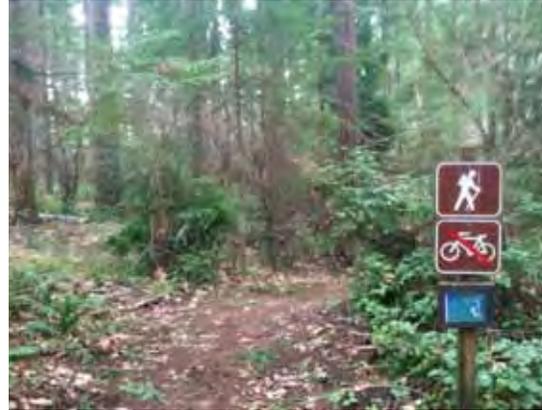
## NORTH LOOP

This trail is on much more stable soil and is, therefore, not subject to the same erosion issues as the beach loop trail. Some portions are quite steep, but the trail provides excellent views of Cutts Island and Colvos Passage. There are several good examples of pistol butt trees resulting in some interesting shapes.

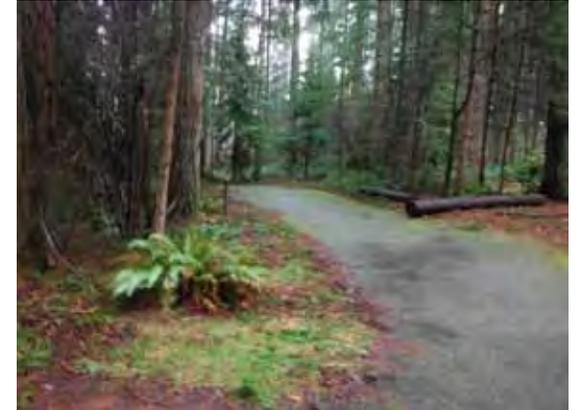
## UPPER CAMPGROUND LOOP

The existing asphalt-paved surface of the former campground loop road is gradually being obscured by moss. Nevertheless, it still provides a suitable walking surface: the majority of the trail is less than 5% slope and could be considered wheelchair accessible.
