# Mystery Bay State Park Pier Repair Project

## Project Description

August 20, 2024

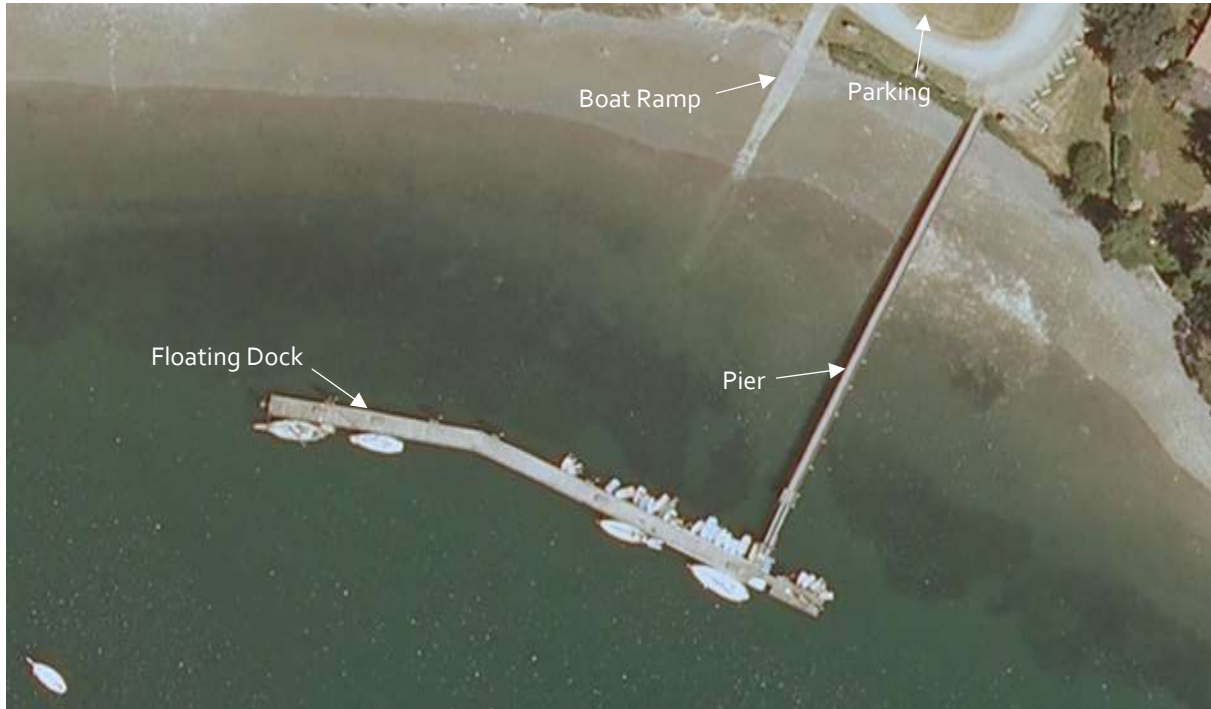
Figure 2. Project Aerial

The shoreline at Mystery Bay State Park adjacent to the pier and boat ramp is characterized by a three to five-foot vegetated bluff (M&N 2022). The shoreline consists of native vegetation, maintained grassy areas near the shoreward portion of the boat ramp, and a small area of riprap around the pier abutment (Figure 3). Substrate along the shoreline consists of sand with shall fragments including an oyster bed adjacent to the pier (Figure 3).

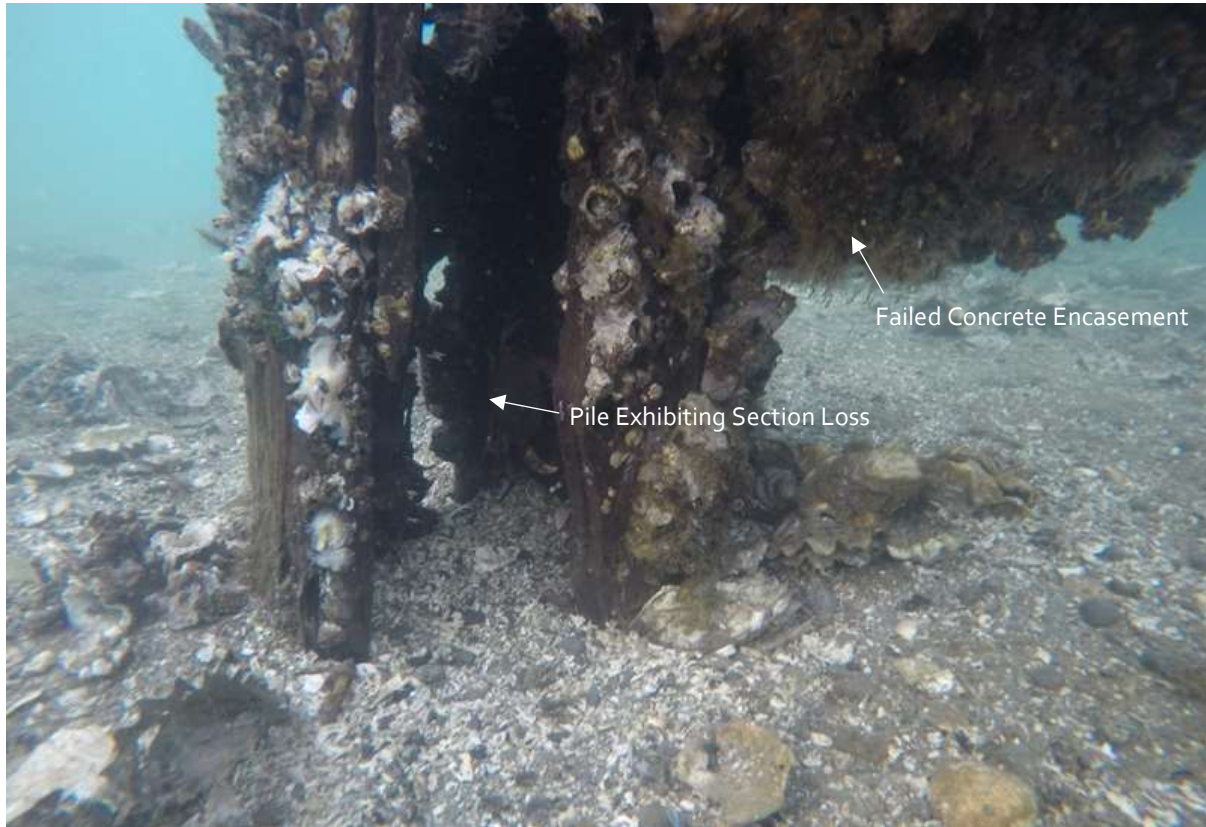
M&N conducted an above-water and underwater investigation of the pier on November 17, 2020 (M&N 2021). Follow-up investigations were performed on October 6, 2023. The findings of the M&N investigation concluded that several piles, pile caps, and cross braces are exhibiting major to severe damage. The remaining structure (i.e. stringers, decking, and handrails) exhibits minor to moderate damage. Due to the severity of the damage to structural elements, the pier has been temporarily closed to protect public safety. The pile at bent 7 appears to have been previously encased with concrete, however the concrete encasement has failed and exposed the deteriorated timber pile (Figure 4). The timber pile exhibits section loss of up to 90%, several of the pile caps exhibit up to 50% section loss (Figure 5), and eight cross braces exhibit up to 75% section loss (Figure 6). Six additional cross braces require replacement due to the installation of pile posts at those locations. Additionally, four other piles exhibit section loss of greater than 50% section loss and require repair.

Figure 4. Visual Pile Inspection with Hammer to Detect Voids

Five existing creosote-treated piles at Bents 2, 4, 5, 7, and 9 will be repaired by cutting the existing pile, approximately two feet below the mudline, and installing a steel pile post on top of the existing pile. The steel pile post will be connected to the pile stub through the placement of concrete and a steel drift pin. A stay-in-place form/sleeve will be placed around the interface between the existing pile and the steel pile post to confine the concrete. Construction will be completed at low tide in the dry using a mini excavator and hand tools.

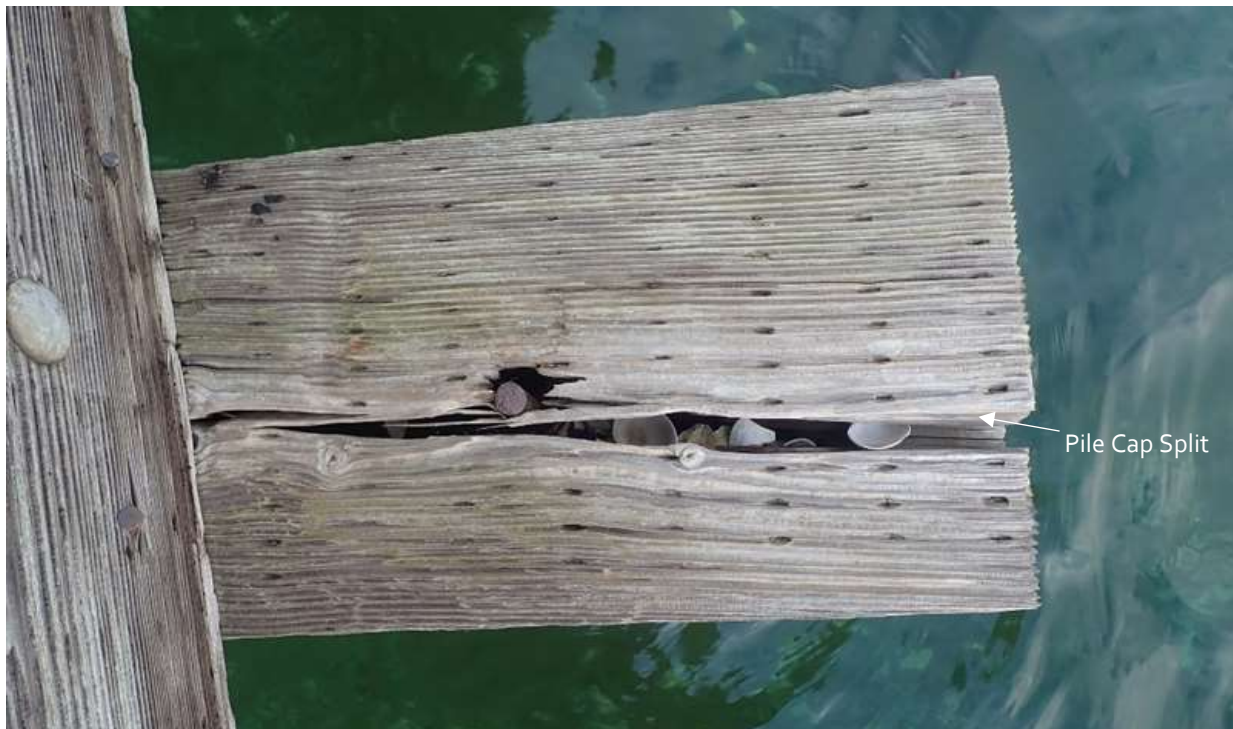
*Figure 5. Pile Cap with Major Split and Rot*

Nine pile caps at bents 1, 2, 3, 5, 6, 7, 12, 13, and 14 will be replaced using hand tools. The existing pile caps are creosote-treated and will be replaced with ACZA-treated timber pile caps of similar dimension. The exposed ends of the proposed pile caps will be covered with roofing felt (wood cellulose based material often used to protect exposed timber members in waterfront structures) to prevent leaching from direct contact with precipitation. Seven sets of cross braces at bents 2, 4, 5, 7, 9, 12, and 13 will be replaced using hand tools. The existing creosote-treated cross braces will be replaced with steel cross braces.

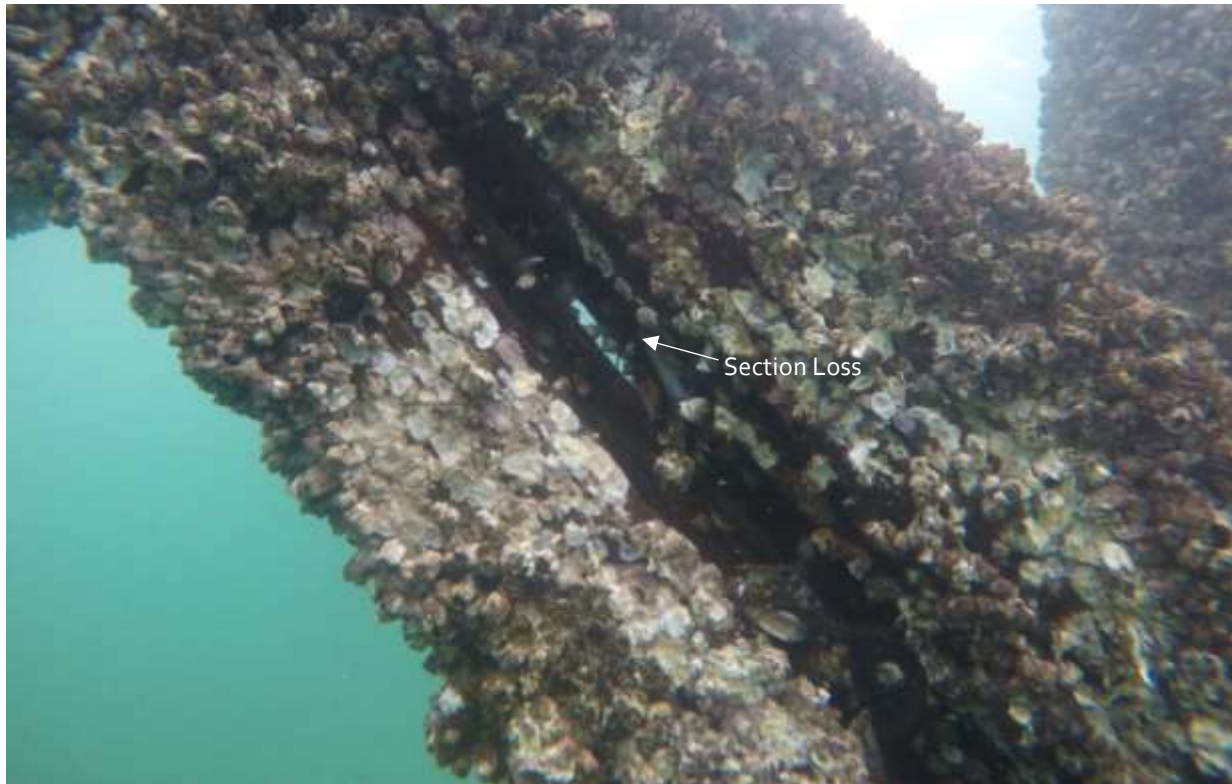
*Figure 6. Cross Brace with Section Loss*
